UAS LIMITED OCCURRENCE INVESTIGATION REPORT – FINAL

Reference Number		CA18/2/3/10332							
Classification		Accident	Date		15 June 2023	Time		1711Z	
Type of Operation		Remotely Piloted Aircraft Systems – Aerial Survey (Part 101)							
Location									
Place of Departure		Anglo American Platinum – Mogalakwena Mine, Limpopo Province		Place of Intended Landing		Anglo American Platinum – Mogalakwena Mine, Limpopo Province			
Place of Occurrence		Anglo American Platinum – Mogalakwena Mine, central pit block near Waterberg							
GPS Co-ordinates		Latitude	23° 57' 21.78" S	Longitude	028° 53' 04.43" E	Elevation	3 569 ft		
Aircraft Information									
Registration		ZT-XHU		Class		4A			
Make; Model; S/N		DJI; Matrice 300 RT (Serial Number: 1ZNBj6R00C005Q)							
Damage to Aircraft		Substantial		Total RPAS/UAS Hours			98.10		
Pilot-in-command									
Licence Type		Remote Pilot Licence (RPL)		Gender		Male		Age	27
Licence Valid		Yes	Total Hours		161.54	Total Hours on Type		161.54

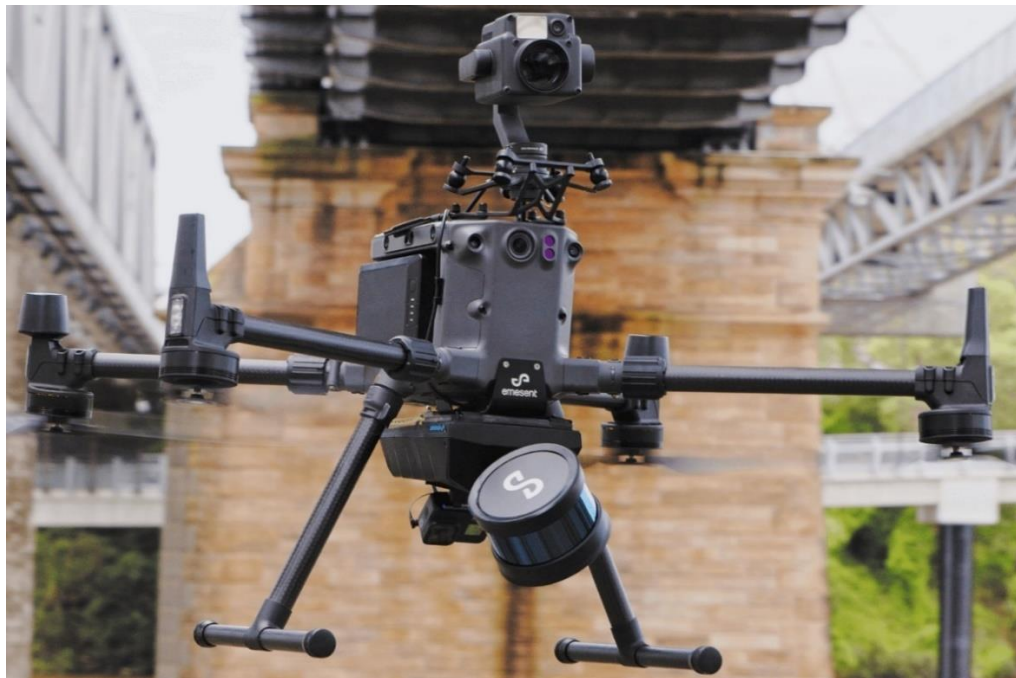
Figure 2: An example of a DJI Matrice 300 similar to the one that was involved in an accident.
(Source: <https://enterprise.dji.com/ecosystem/hovermap>)

Total Hours 30 Days		11.53		Total Flying on Type Past 90 Days			29.57		
Injuries	0	Injuries (On ground)	0	Fatalities	0	People Controlling	2		
What Happened									
<p>On Thursday, 15 June 2023, a DJI Matrice 300 RT Unmanned Aircraft System (UAS) with registration ZT-XHU was launched for a time study on the quarry pit blast block at Anglo American Platinum Mogalakwena Mine, Limpopo province. The flight was conducted under beyond visual line of sight (BVLOS) rules by day and under the provisions of Part 101 of the Civil Aviation Regulations (CAR) 2011 as amended.</p> <p>The pilot who was the secondary pilot-in-control (S-PIC) reported that the controls of the UAS were handed over from the primary pilot-in-command (P-PIC) who was busy with the ground control points (GCP) plotting. He stated that he set up and conducted a pre-flight inspection on the UAS and, thereafter, attached the camera. He then launched the UAS as per the mission plan. As the UAS was en route to the starting position, three error messages popped up on the remote pilot station screen. He then observed the UAS spiral down uncontrollably and, moments later, it crashed. The S-PIC and P-PIC rushed to the crash site to find the UAS substantially damaged. There were no injuries reported on the ground.</p> <p>Post-flight inspection revealed that one of the propeller blades had detached in-flight. The S-PIC had conducted the pre-flight inspection in haste and did not ensure that the propeller was secured properly.</p>
