LIMITED OCCURRENCE INVESTIGATION REPORT – FINAL

Reference Number	CA18/3/2/1409						
Classification	Serious Incident	Date	28 February 2023	Time	2328Z		
Type of Operation	Remotely Piloted Aircraft System – Aerial Survey (Part 101)						
Location							
Place of Departure	Paulpietersburg (Dumbe), KwaZulu-Natal Province		Place of Intended Landing	Paulpietersburg (Dumbe), KwaZulu-Natal Province			
Place of Occurrence	Near Paulpietersburg (Dumbe), Kwa Zulu Natal Province						
GPS Co-ordinates	Latitude	27° 27' 54" S	Longitude	030° 49' 55" E	Elevation	3773ft	
Aircraft Information							
Registration	ZT-YPH						
Make; Model; S/N	DJI; Mavic 2 Enterprise (Serial Number: Mav112)						
Damage to Aircraft	None		Total Aircraft Hours	150.34			
Pilot-in-command							
Licence Type	Remote Pilot Licence (RPL)		Gender	Male		Age	32
Licence Valid	Yes	Total Hours	176.79		Total Hours on Type	176.79	
Total Hours 30 Days	16.04		Total Flying on Type Past 90 Days			105	
People Controlling	1	Injuries	0	Fatalities	0	Other (on ground)	0

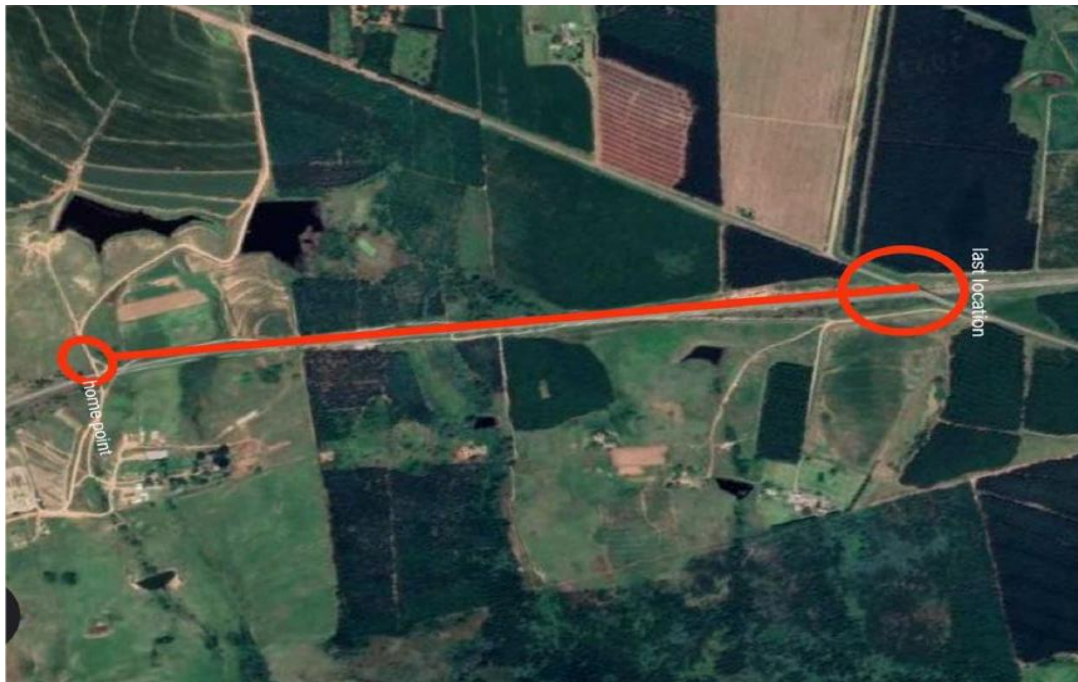
Figure 1: Circle on the left indicate launch position and on the right it shows the accident site. (Source: Google)

6. Following the controller unit disconnection, the pilot made his way to the last known location but could not locate it. The search was continued the next day with no success. The RPA was found 30 days later in the vicinity of its operation and in good condition.

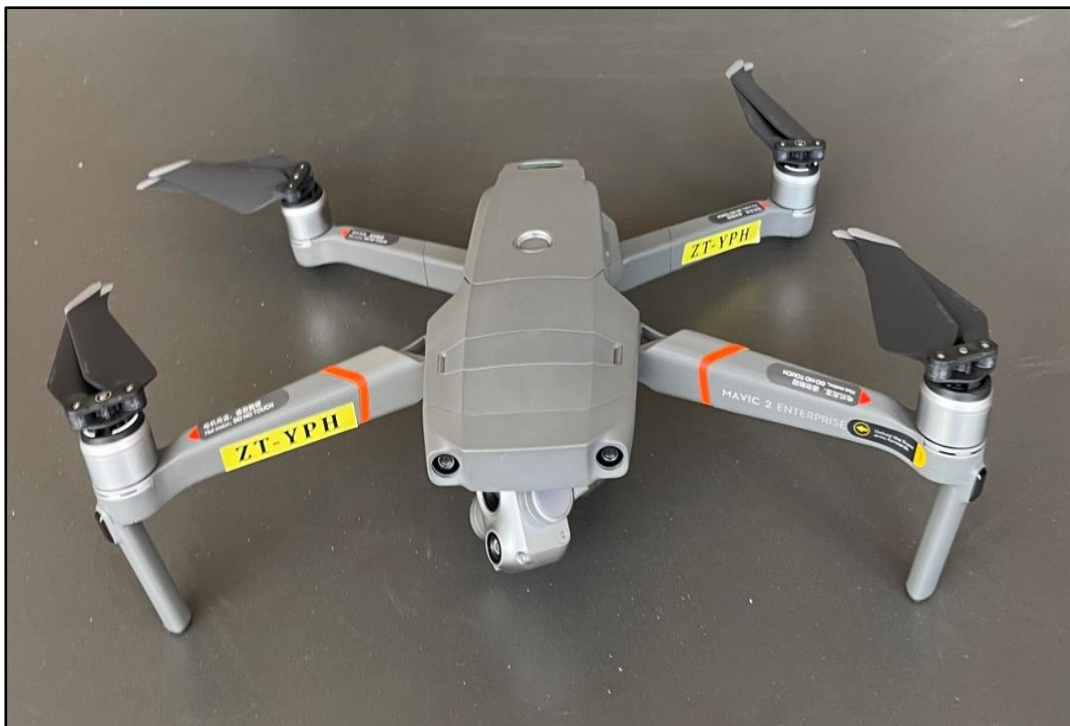
Figure2: Mavic 2 Enterprise remotely piloted aircraft (RPA) type. (Source: Operator)
