AIRCRAFT SERIOUS INCIDENT REPORT AND EXECUTIVE SUMMARY

Reference:		CA18/3/2/1453					
Aircraft Registration		ZT-RFJ (R44) and ZU-TEX (SLING 4)		Date of Incident		20 August 2024		Time of Incident		1421Z	
Type of Aircraft		Robinson R44 II and Sling 4				Type of Operation		Part 141 and Part 148			
Pilot-in-Command Licence Type (ZT-RFJ)				Commercial Pilot Licence		Age	29	Licence Valid		Yes	
Pilot-in-Command Flying Experience				Total Flying Hours		1 730.0	Hours on Type		804.3		
Pilot-in-Command Licence Type (ZU-TEX)				Commercial Pilot Licence		Age	56	Licence Valid		Yes	
Pilot-in-Command Flying Experience				Total Flying Hours		3 715.5	Hours on Type		550.0		
Last Point of Departure (ZT-RFJ)				Grand Central Aerodrome (FAGC), Gauteng Province							
Last Point of Departure (ZU-TEX)				Grand Central Aerodrome (FAGC), Gauteng Province							
Next Point of Intended Landing (ZT-RFJ)				Grand Central Aerodrome (FAGC), Gauteng Province							
Next Point of Intended Landing (ZU-TEX)				Tedderfield Aerodrome (FATA), Gauteng Province

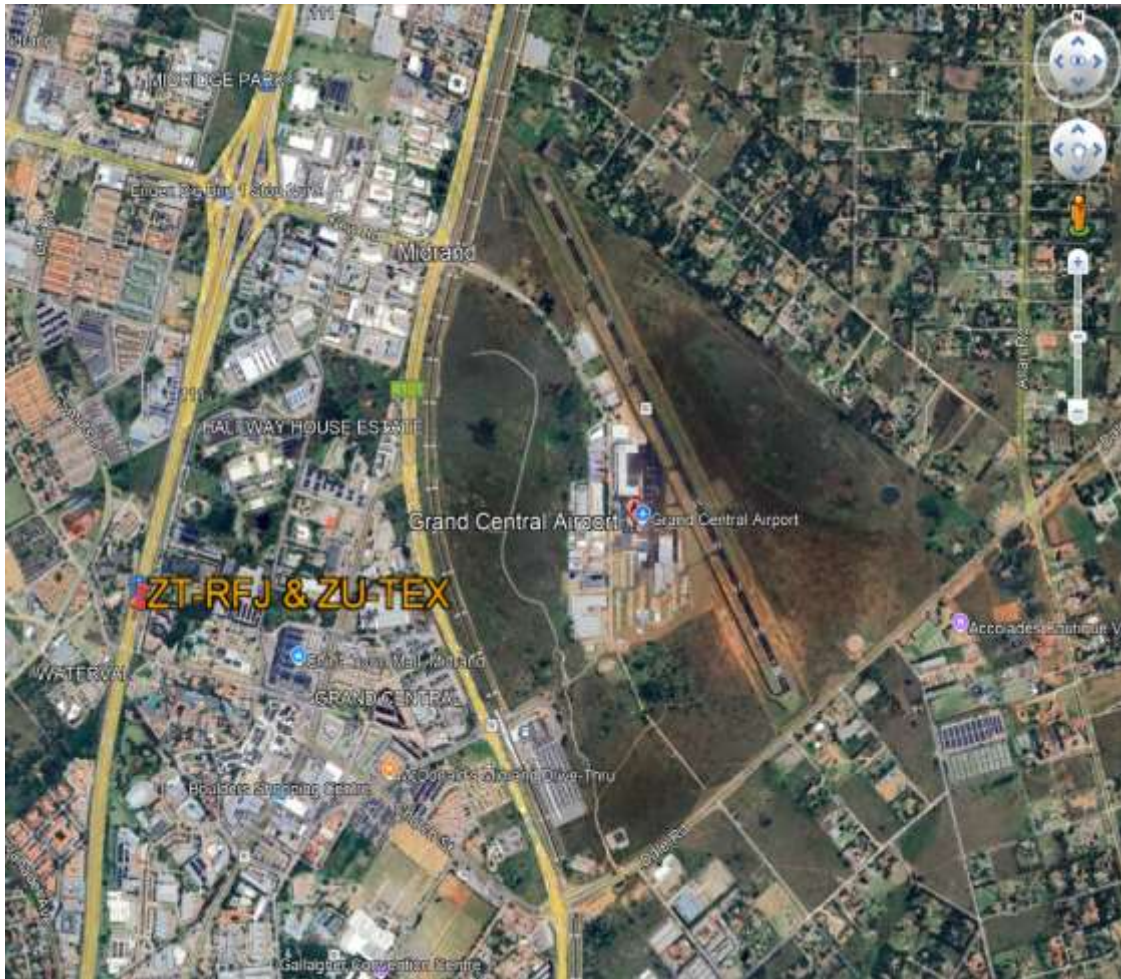
1.1.4 The serious incident occurred during daylight on early left downwind Runway (RWY) 35 at

FAGC at Global Positioning System (GPS) co-ordinates determined to be: 25° 59' 28" South
28° 07' 23" East, at an elevation 5056 feet (ft)

Figure 1: FAGC layout. (Source: Google Earth)

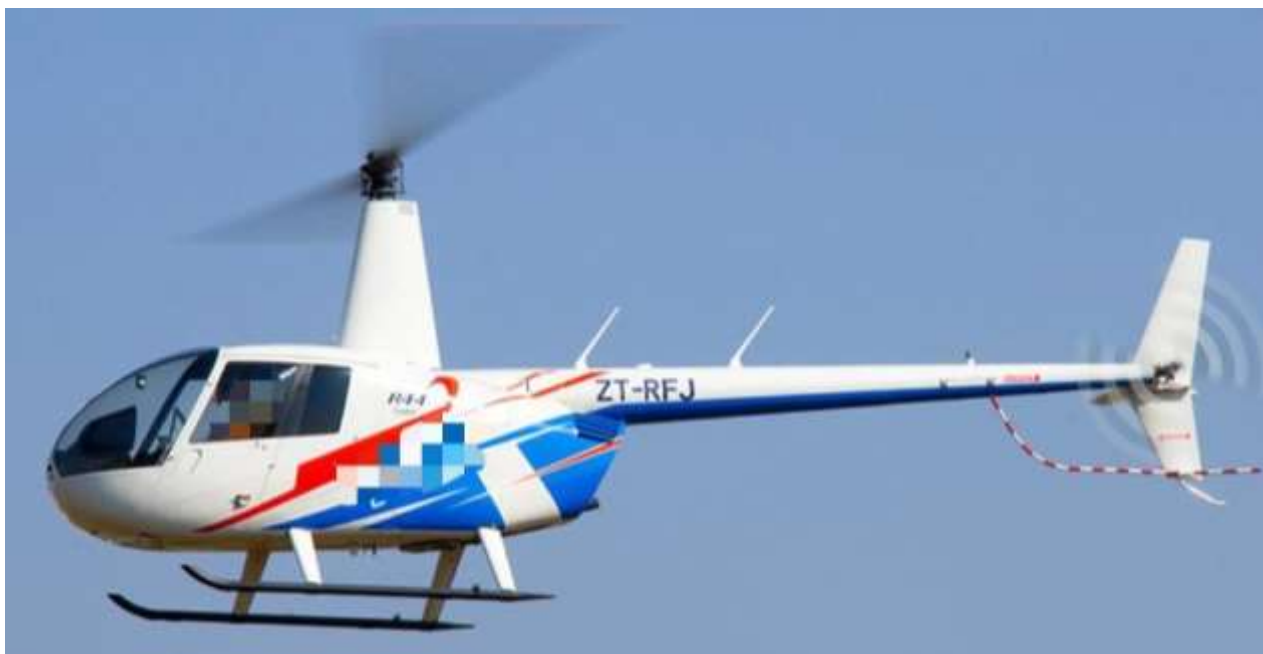
1.6.1 Robinson R44 Raven II Helicopter Description (Source: Pilot's Operating Handbook [POH])

The Robinson R44, Raven II is four-seater light helicopter powered by a Lycoming IO-540-EA1A5 six-cylinder fuel injected engine, bearing serial number L-27974-48E. The helicopter comprises skid-type landing gear and has a counter-clockwise rotating two-bladed main rotor with a diameter of 10.06 metres (m), and a two-bladed tail rotor with a diameter of 1.47m. A cyclic control stick is located between the front seats and operated via a control grip in front of the pilot. The control grip is fitted to a cross tube connected to the cyclic control stick. A collective control lever is located to the left of each front seat; a twist-grip throttle control is located on each collective lever. The revolutions per minute (RPM) governor assists in controlling the engine RPM under normal conditions and can be over-ridden by the pilot using the throttle twist-grip.

Figure 2: ZT-RFJ helicopter.
