INTERIM STATEMENT

Accident and Incident Investigations Division

Accident
Interim Statement -
AIID Ref No: CA18/2/3/10072

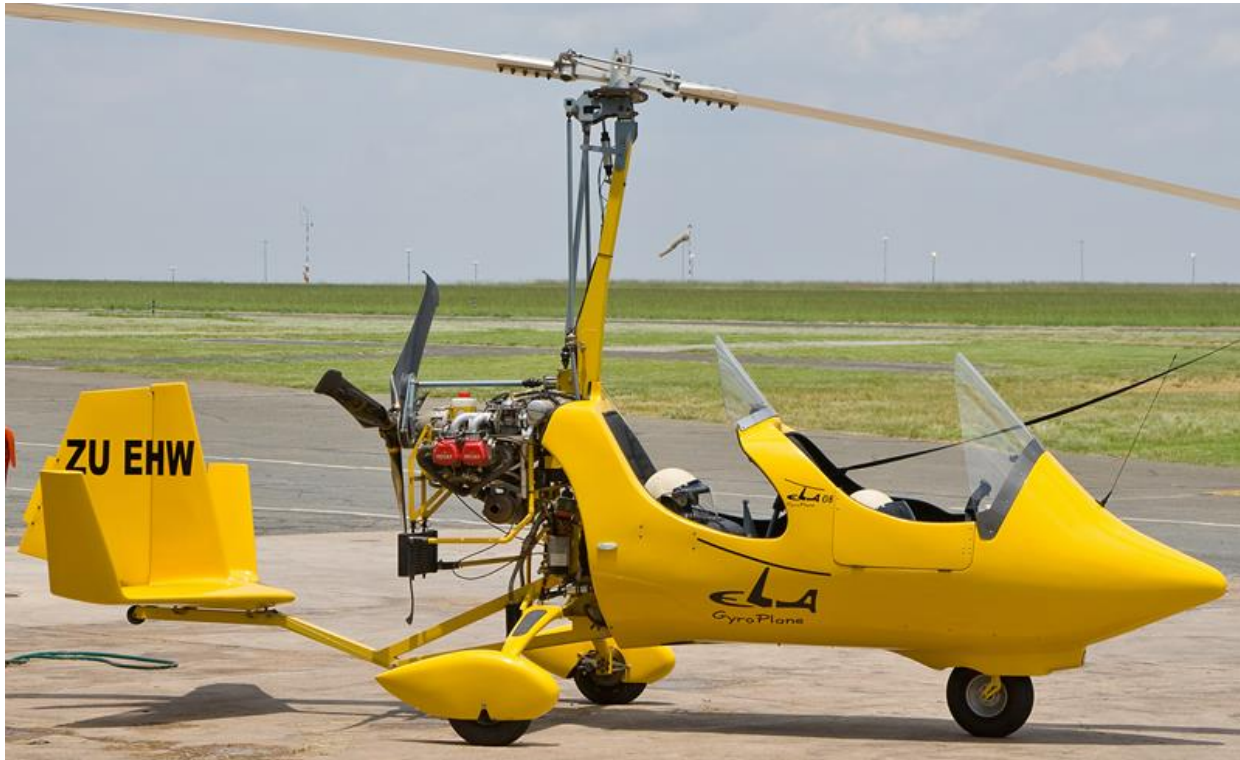
Figure 1: The file picture of the ZU-EHW gyrocopter. (Source: www.surfacezero.com [photo album])
