LIMITED OCCURRENCE INVESTIGATION

Reference Number	CA18/2/3/10004						
Classification	ACCID	Date	14 May 2021	Time	1554Z		
Type of Operation	Private Part 91						
Location							
Place of Departure	Rand Airport (FAGM)		Place of Intended Landing	Vaal, Burgundy Bay			
Place	Vaal Marina Bay, Vaal Dam, Gauteng Province						
GPS Co-ordinates	Latitude	S26°54'28.1"	Longitude	E028°12'37.0"	Elevation	4900ft	
Aircraft Information							
Registration	ZS-RSK						
Model/Make	Robinson R44 Raven II						
Damage to Aircraft	Substantial		Total Aircraft Hours	2596.5			
Pilot-in-command							
Licence Type	Private Pilot Licence	Gender	Male	Age	59		
Licence Valid	Yes						
Total Hours on Type	±900		Total Flying Hours	909.7			
People On-board	1+1(+2 dogs)	Injuries	0	Fatalities	1+1+2	Other (On Ground)	0
What Happened							
<p>On 14 May 2021, a Robinson R44 Raven II helicopter with registration mark ZS-RSK was involved in a fatal accident in the Vaal Marina Bay, Gauteng province. On-board the helicopter were two occupants, the pilot-in-command who was seated on the right-side of the helicopter, and the passenger seated on the left-side. The pilot and the passenger had two dogs with them, which were on

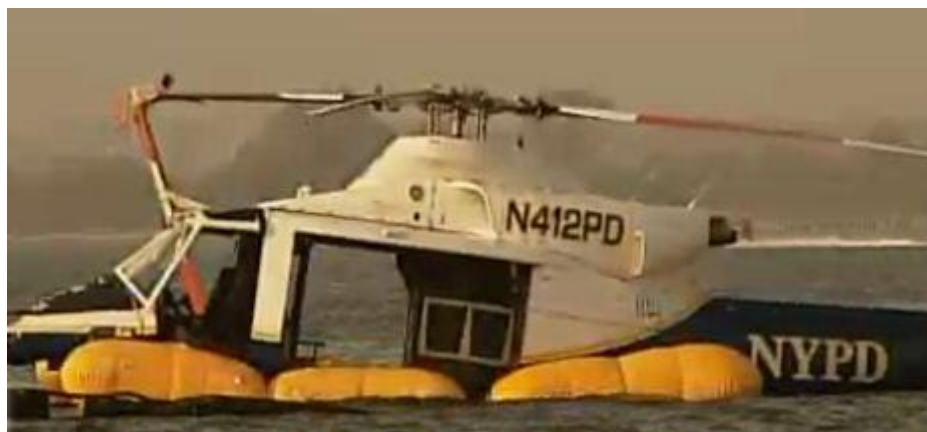
Figure 1: A helicopter fitted with floatation devices. (Source: New York Police Department website)

The fitting of an EFS based on floats is well established but the problem of instability on anything but a calm water surface has always been problematic. This is because of the relatively high center of gravity of helicopters due to the location of the rotors, the transmission, and the engines.

The floats which provide EFS buoyancy are either packed within spaces inside the airframe or fitted as externally mounted packs on the lower structure. Inflation is provided by gas stored in pressurized cylinders which are carried on board. The need for rapid inflation is met by the inclusion of helium in the gas but it is usually blended with other gases.
