**IATA Super-absorbent Polymer (SAP) Special Interest Group –  
Data summary and proposed roadmap**

On 14 November 2017 the IATA SAP Special Interest Group released the statement shown in Appendix A. This paper provides a summary of the information on which the statement is based and the roadmap that is proposed by the group for adoption by all stakeholders.

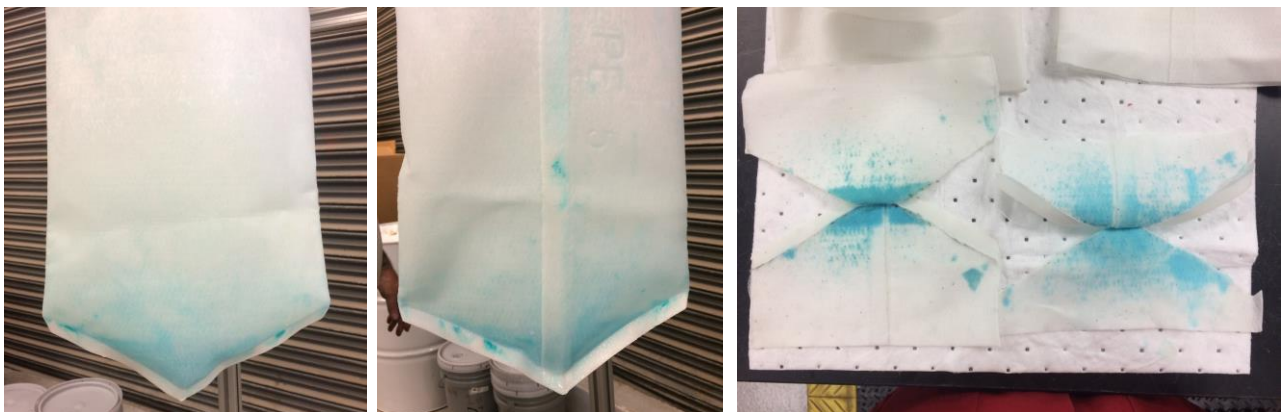
**Figure 3 – Visual indication of quantity of SAP migration from the elements from Manufacturer A (SAP particles/gel dyed blue, collected in bag filters from test rig)**
