AIRCRAFT INCIDENT REPORT AND EXECUTIVE SUMMARY

Reference: CA18/3/2/0965	
Aircraft Registration	ZS-ZWP	Date of Incident	27 February 2013		Time of Incident 1155Z
Type of Aircraft	Boeing 737-800		Type of Operation		Domestic Schedule
Captain Licence Type	Airline Transport Pilot	Age	43	Licence Valid	Yes
Captain Flying Experience	Total Flying Hours	7 738,0		Hours on Type	450,5
First Officer Licence Type	Airline Transport Pilot	Age	32	Licence Valid	Yes
First Officer Flying Experience	Total Flying Hours	6 700,0		Hours on Type	570,0
Last point of departure	Cape Town International Airport (FACT)				
Next point of intended landing	OR Tambo International Airport (FAOR)				
Location of the incident site with reference to easily defined geographical points (GPS readings if possible)					
On Runway 01 at Cape Town International Airport (FACT)					
Meteorological Information	Surface wind: 330°/22 kt, Temperature: 24 °C, Dew point: 16 °C, Cloud cover: 1-2 octas, Cloud base: 3500 feet AGL

Probable cause					
Aborted take-off as a result of the No. 2 engine failure due to the failure of the HPT blade.					
Contributory factor					
Failure of the HPT blade coating resulting on a corrosion and a subs

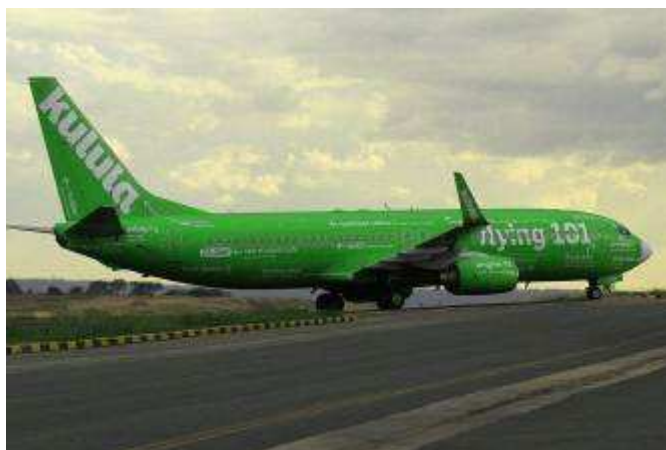
Figure 5: A photo of the aircraft as it came to rest on the runway

1.12.1 The aircraft came to a stop on Runway 01 following a RTO by the crew, as the speed was still fairly slow (before V1) when the engine failed.

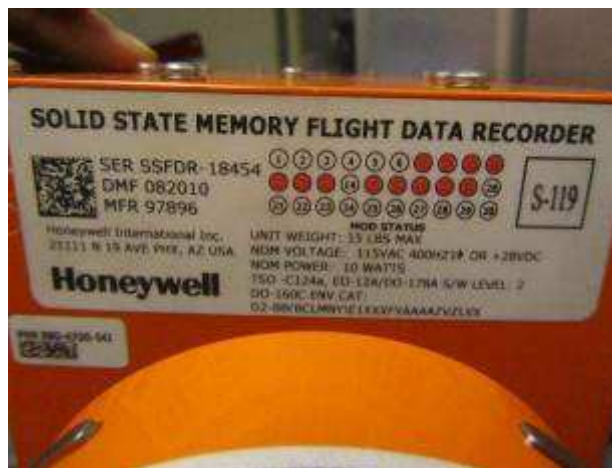
Figure 7: Flight data recorder (FDR) recovered from the aircraft

1.11.6 An external examination on both recorders revealed that both units were in good condition. The underwater locator beacons on both recorders were also not damaged.

1.11.7 The FDR data download did not show any abnormalities before the event occurred.

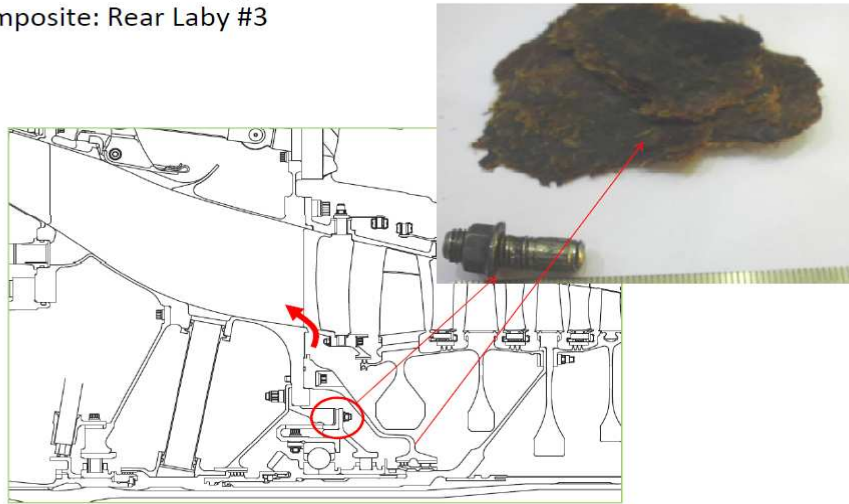
Figure 16: Schematic diagram showing the location of the stud and nut and seal.

1.16.5 After the engine was completely stripped the position of the studs were confirmed. The composite material was also identified as a seal. Refer to figure 16 for a schematic diagram showing the location of the stud and nut and seal.

ESN 890-816 Findings & CFM hypothesis
Stud+Nut : N°3 Bearing attachment
Composite: Rear Laby #3

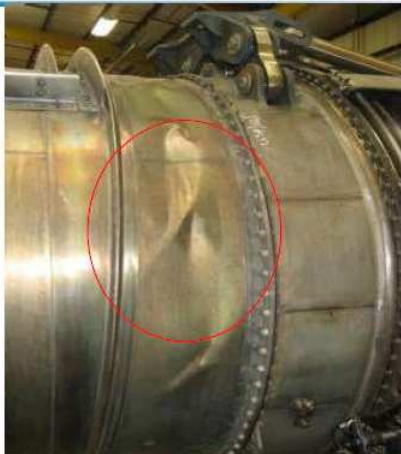
Debris outside the LPT in tailpipe.

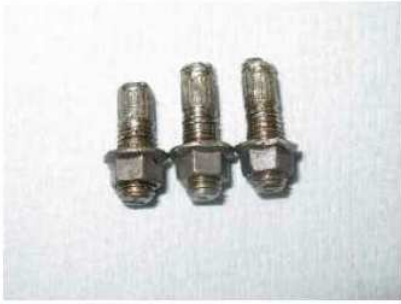
1.16.3 Figure 13 below shows two studs (part number J1074P10) were found lying at the bottom of the engine cowling. The nuts (part number J149P07) were still attached to the studs, which displayed evidence of deformation (bending) as well as shearing. The studs are made of a material called Inconel 718 and the nut is AMS 5735 which is Stainless Steel A268.

Separated attachment studs

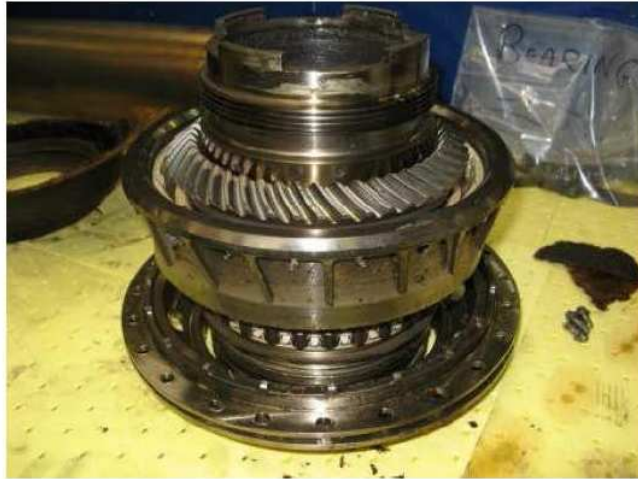
No 3 bearing

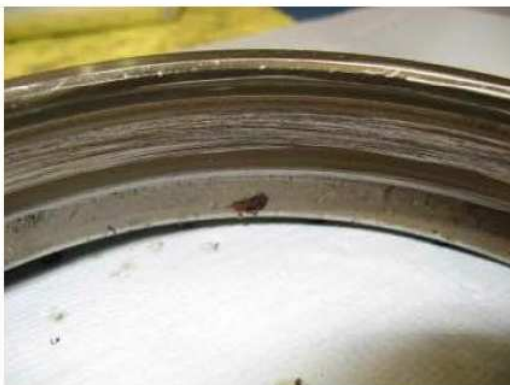
No 3 roller bearing outer race

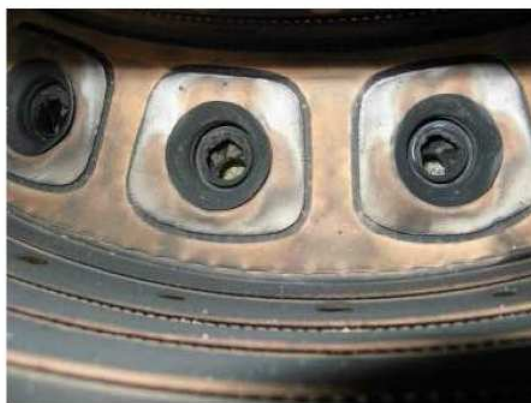
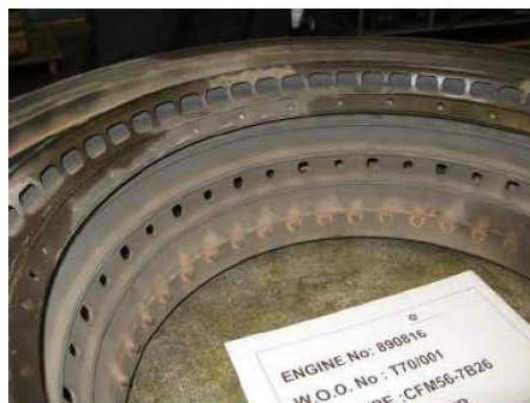
Combustor case in good condition

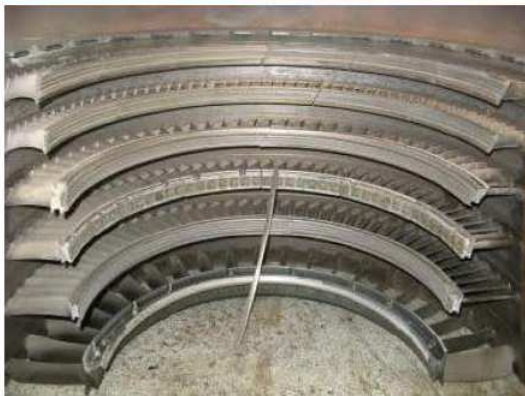
HPC forward stator case

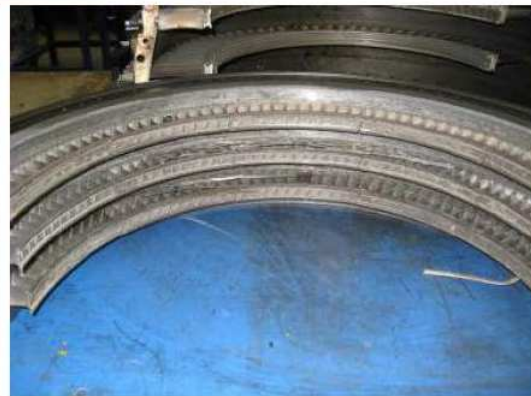
HPC rear stator case stators

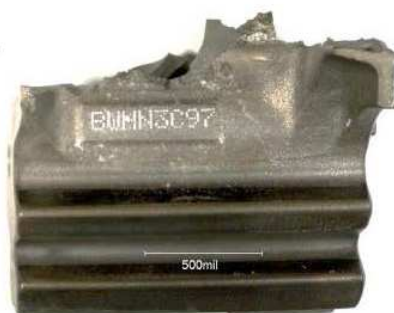
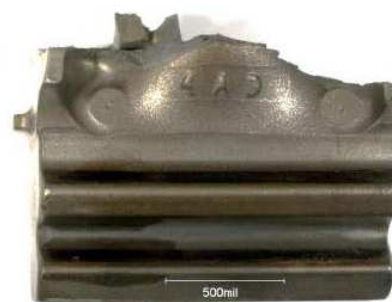
Figure 2. Overviews of blade BWHN3C97 that separated under the platform.

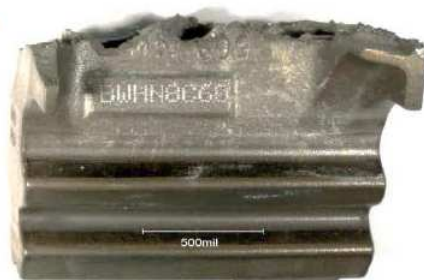
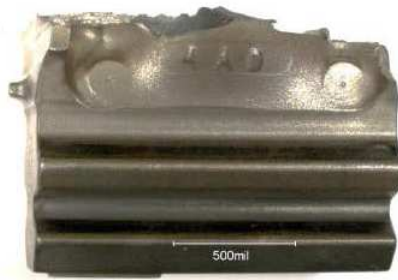
Figure 3. Overviews of blade BWHN8C60 that separated under the platform.
